Manhole Inspection Summary

Manhole # S21EE_053MH

Insp Date: **7/31/09 1:06 PM**

Location Address: **1422 KAVANAUGH ST**

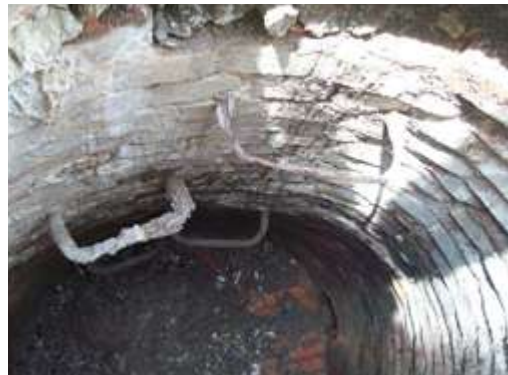
Defect 2

Steps Count: **4** Missing: **0** ☒ **Corroded**

CORRODED STEPS

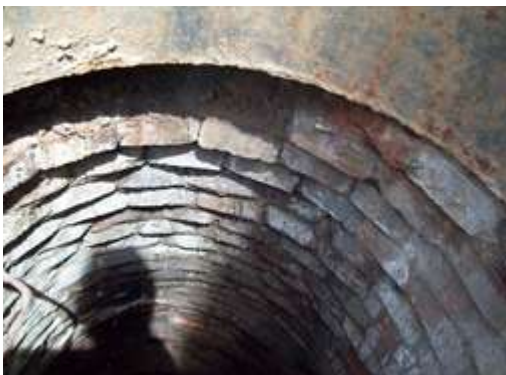
Defect 1

Condition: ☐ Sound ☐ Cracked ☐ Root Intrusion ☒ **Loose Brick** ☐ Deteriorated

LOOSE AND MISSING BRICKS

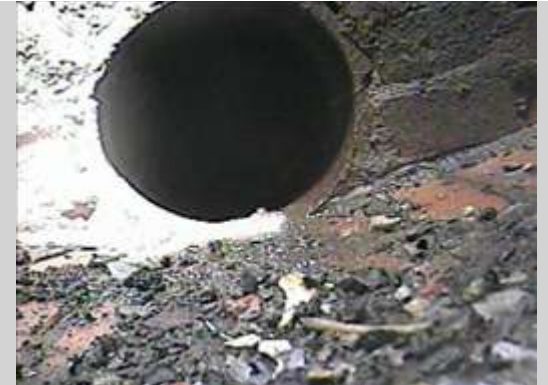
12 O'Clock Outflow

8 in. Circular Gravity Sewer
Pipe Out @ 12 O'Clock

Infiltration: **None** Pipe Seal Cond: **Sound**
